## **Engineering Geological Characteristics and Slope Stability of a Road-Cut Excavated in Serpentine Mélange, Aceh Besar, Indonesia**

**Abstract:** Road-cut slopes excavated in serpentinite mélange are highly susceptible to landslides because of the weak engineering properties of the rock mass, extensive weathering, and intense tectonic deformation. This study aims to investigate the engineering geological characteristics and slope stability of a road-cut excavated through serpentinite mélange in Aceh Besar, Indonesia. Field investigations were conducted to characterize the lithology, weathering conditions, rock mass quality, discontinuity characteristics, and evidence of slope instability. Geological observations were integrated with engineering geological assessments to identify the primary factors controlling slope failure. The investigated slope consists predominantly of highly weathered serpentinite mélange characterized by a heterogeneous rock mass, pervasive fracturing, and a weak serpentinitic matrix. The road excavation has significantly modified the natural slope geometry by increasing the slope angle and removing lateral support, thereby reducing slope stability. Field

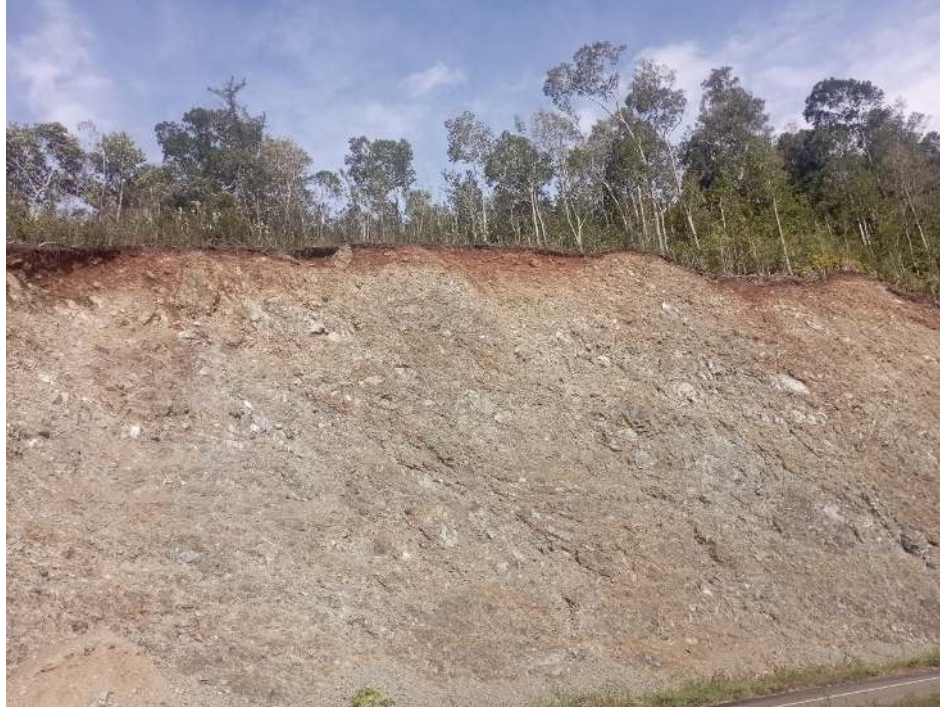
*Figure 1 Field photograph of the investigated road-cut slope exposing highly weathered serpentinite mélange characterized by extensive fracturing, heterogeneous rock mass, and steep excavation geometry.*

The upper part of the slope is covered by a thin layer of reddish residual soil, whereas the lower section exposes highly weathered serpentinite mélange. The slope surface is generally irregular and exhibits evidence of weathering, erosion, and localized rock fragmentation. Loose rock fragments have accumulated at the toe of the slope, indicating ongoing degradation of the exposed rock mass.

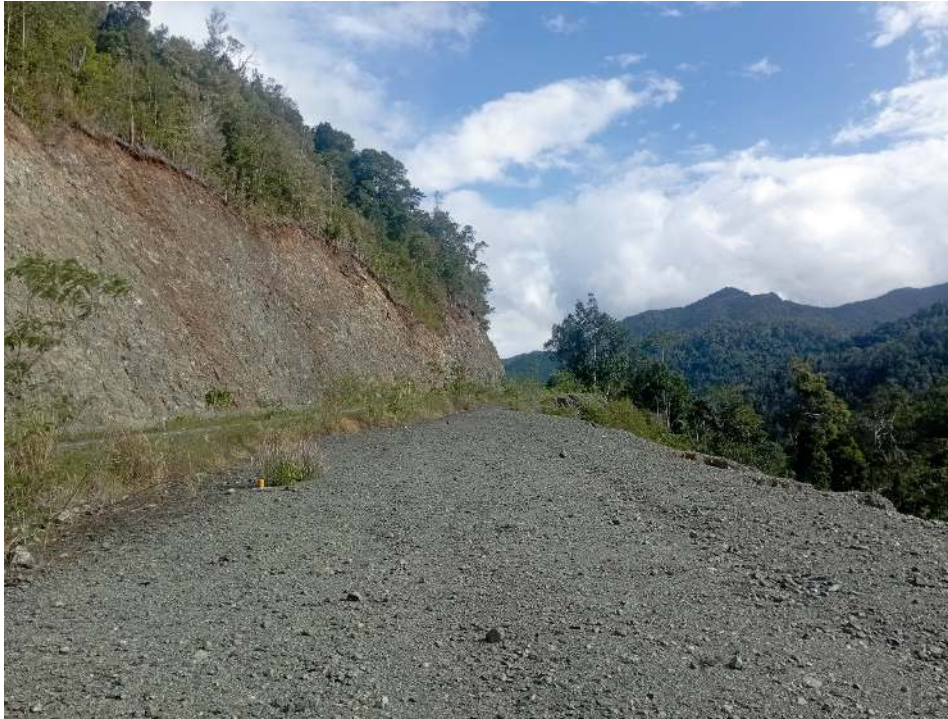
The investigated road-cut slope was excavated to accommodate road construction through mountainous terrain underlain by serpentinite mélange. The excavation produced a steep artificial slope with a considerable vertical height (Figure 2). No engineered stabilization measures, such as benches, retaining walls, rock bolts, or wire mesh, were observed along the exposed slope.

*Figure 2 Road-cut slope excavated through highly weathered serpentinite mélange, showing steep slope geometry, intense weathering, and fractured rock mass conditions.*

Appropriate stabilization measures should include optimized slope geometry, bench construction, surface and subsurface drainage systems, rockfall protection, and revegetation to minimize erosion. Where discontinuities are abundant, additional reinforcement such as rock bolts, shotcrete, or retaining structures may be required to improve slope stability.
